MRW Project: S12076

May 3, 2012

**Re: Structural Condition Inspection
Algo Centre Mall, Elliot Lake, ON**

**Re: Structural Review the Parking Deck Structure at
Algo Centre Mall, Elliot Lake**

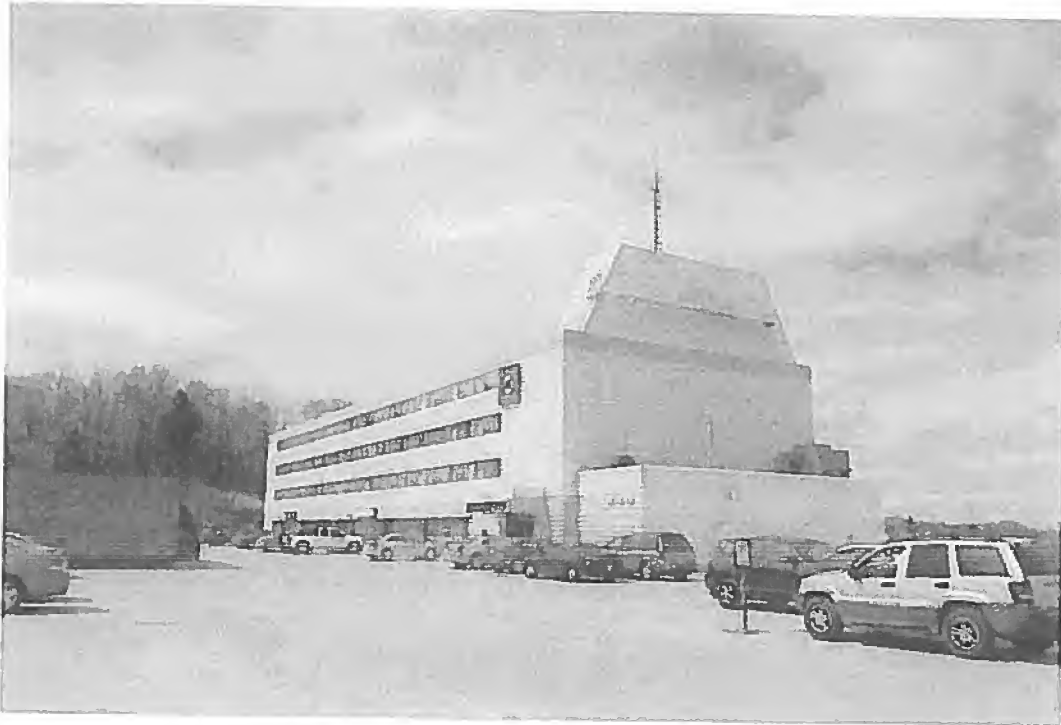
Picture 1: Algo Inn parking deck over mall, lower roof at end in the central boiler room, offices at deck level, three floors of hotel above.

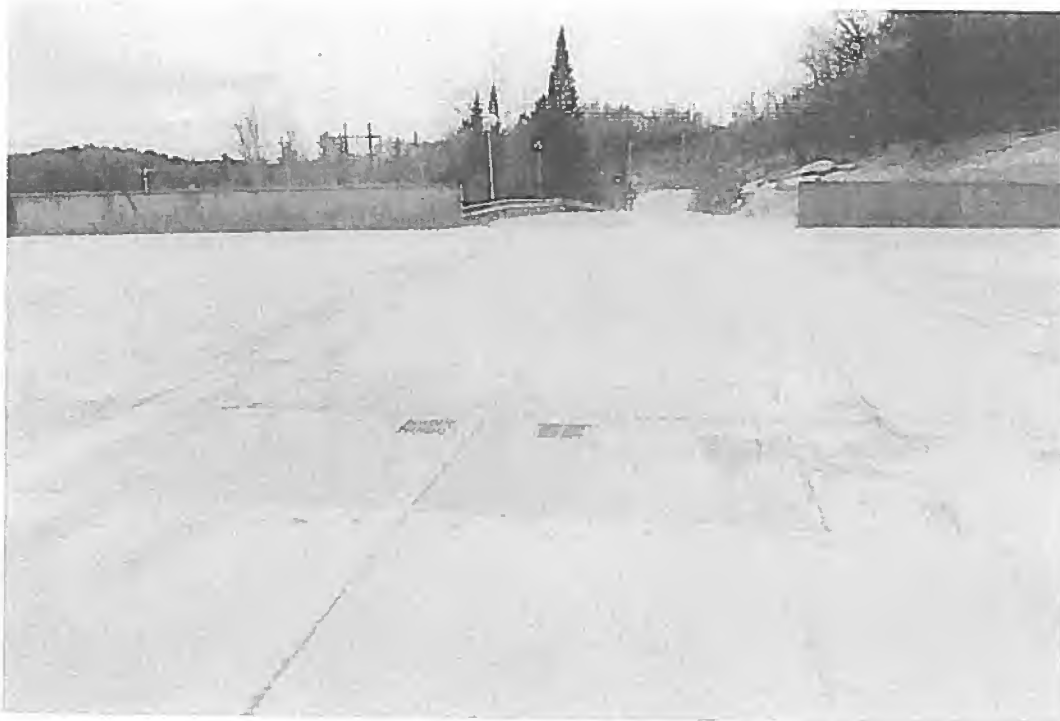
Picture 2: South entry to parking deck above Zellers..

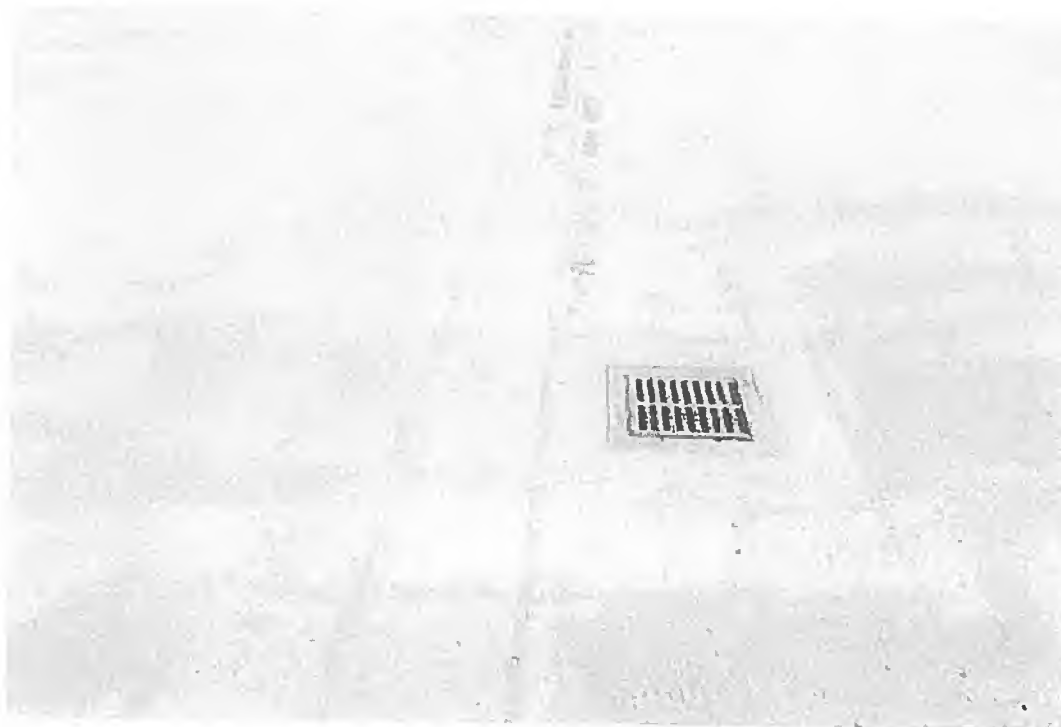
All beams inspected had little loss of section and we would consider the members still structurally sound. The ongoing leakage from the parking deck is of particular concern in the areas of Zellers, and the expansion joint located along the south wall of the Algo Inn, over the municipal library. As per Pictures 5 and 6 we noted vehicular impact on wall siding in this area, that may also have added to the problem.

Picture 3: Parking deck sealant in joints and deck drain above area leaks below in Zellers.

The Mall is conducting further waterproofing maintenance on the parking deck this spring. The upper surface waterproofing is considered only a temporary solution. A permanent repair needs to be budgeted for to suitably protect the structure.

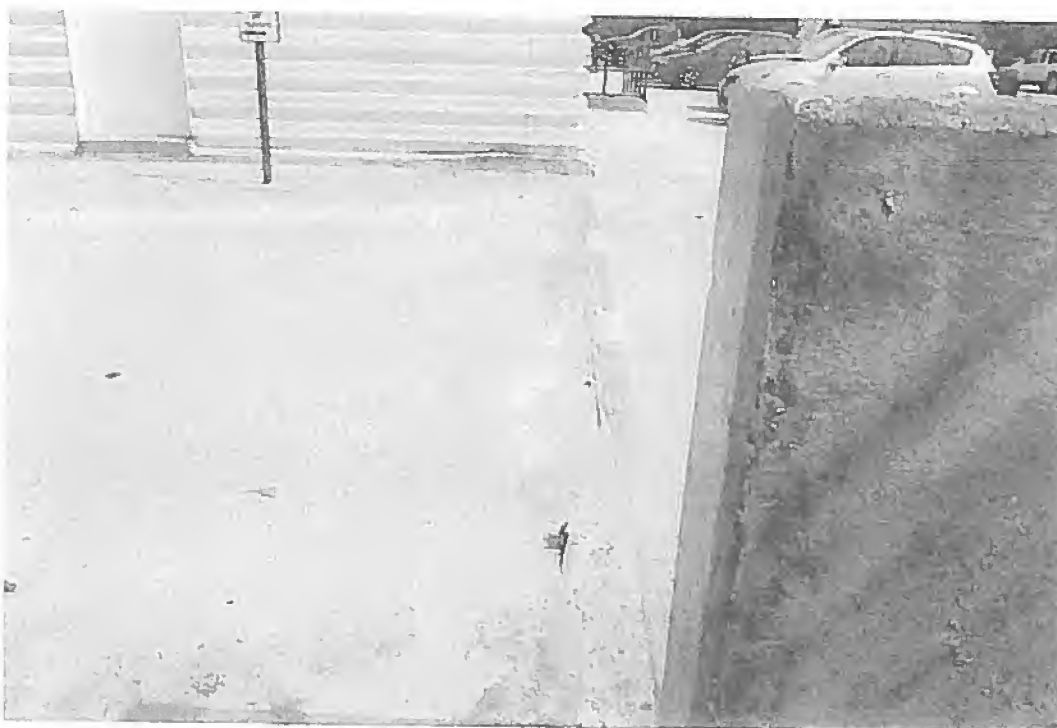
Picture 4: Major expansion joint at SW corner of Algo Inn. Leakage in Library below.

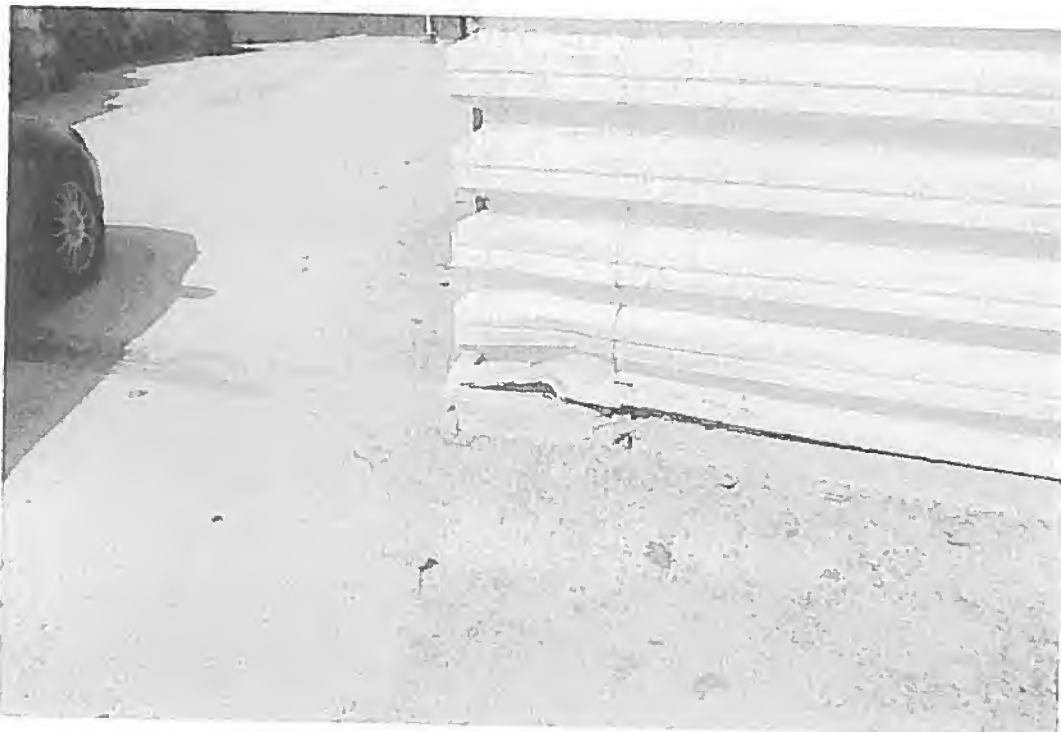
Picture 5: Impact at SW corner of Algo Inn at expansion joint.

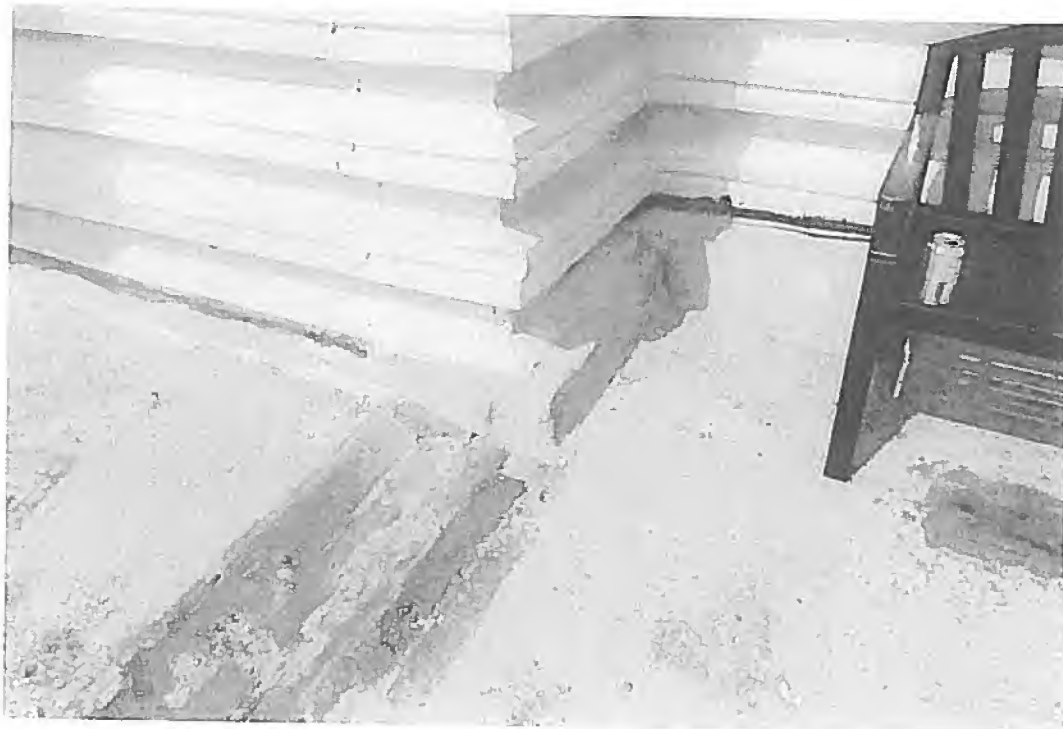
Picture 6: Expansion joint at SE corner of Algo Inn leaks in lottery ticket booth mall below.

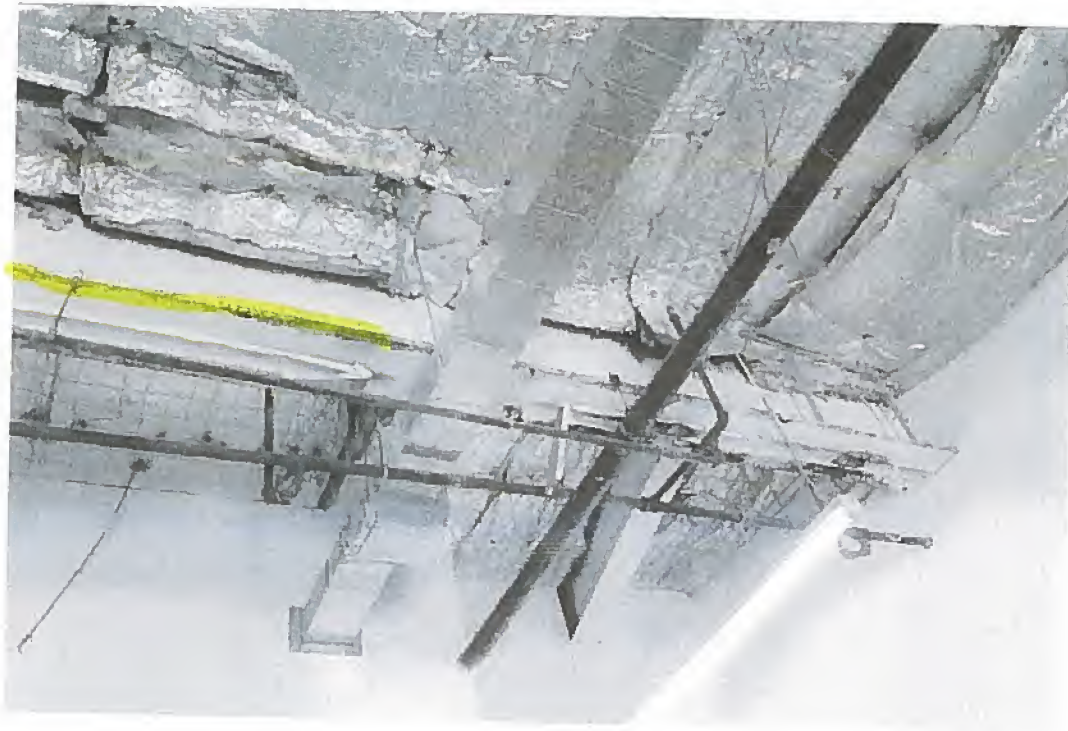
Our inspection revealed evidence of rusting on the structural steel beam members in areas where the parking deck has leaked as shown in Pictures 1 through 8. The area of open walkways shown in Pictures 9 through 12 also have areas with surface rust.

Picture 7: Rusting on steel beams in receiving of Zellers.

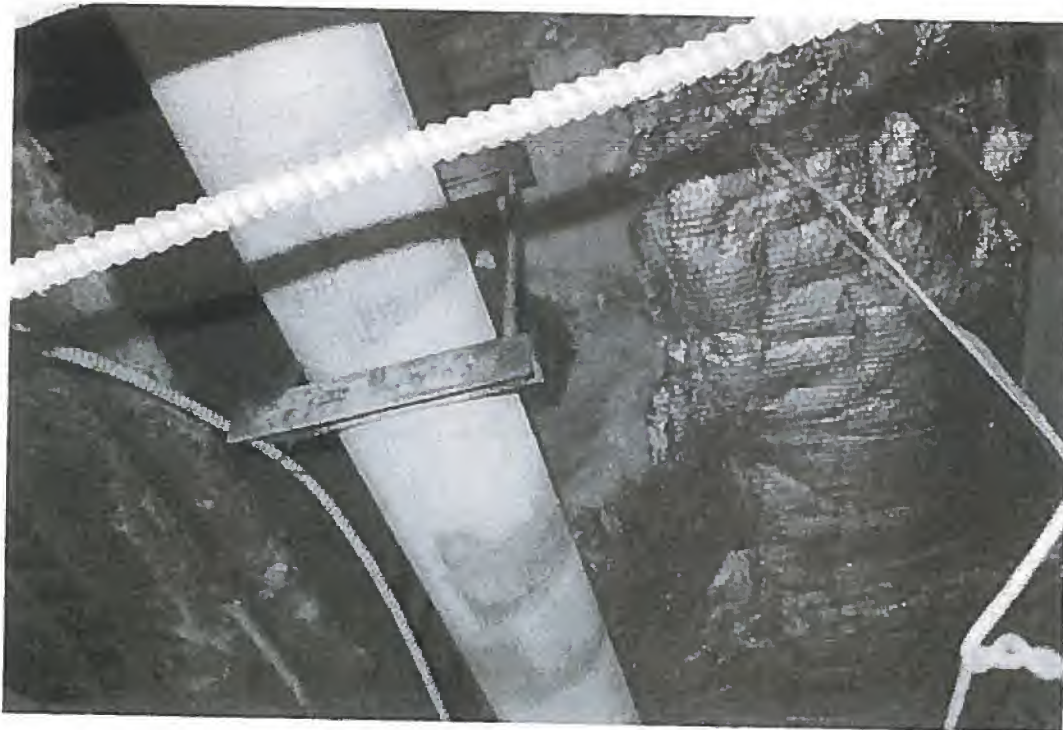
Picture 8: Rusting steel beams and drain pipe below parking deck above Zellers ceiling below Picture 2.

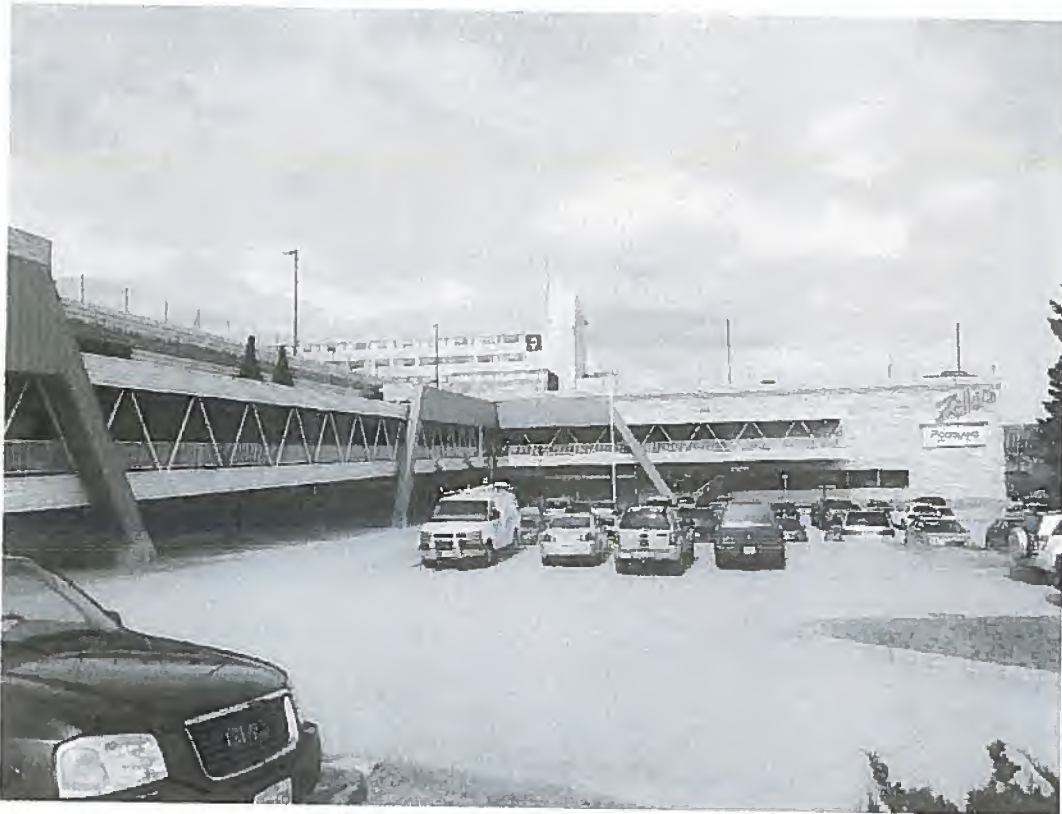
Picture 9: East side open walkways of Algo Mall.

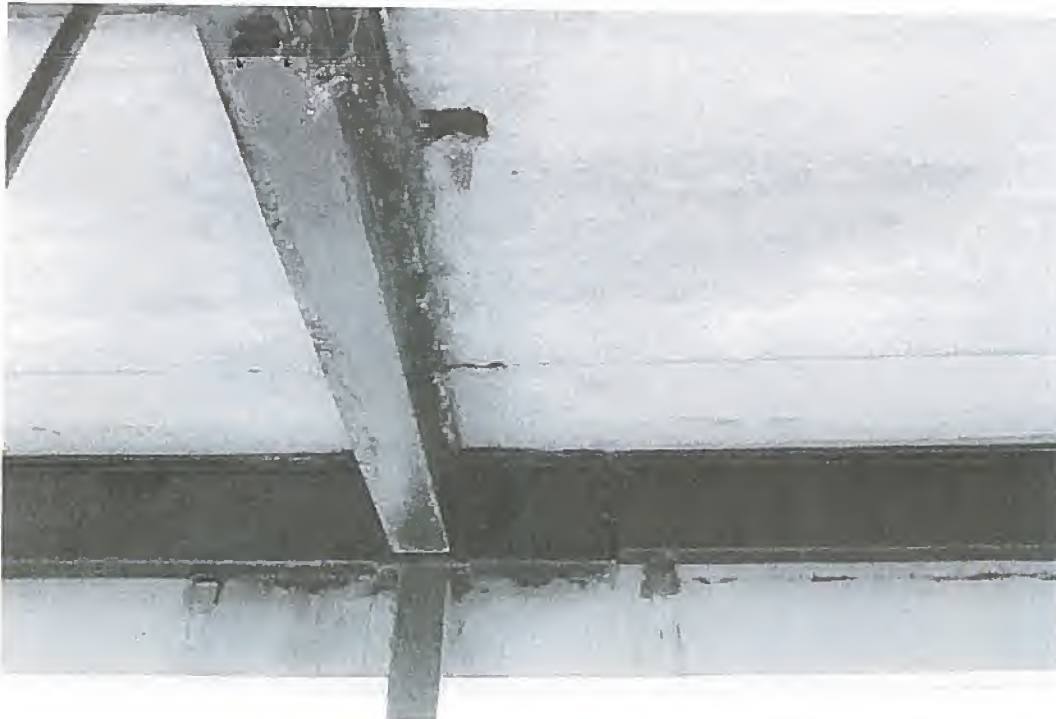
Picture 10: Typical oxidized steel beams underside of deck of open walkways.

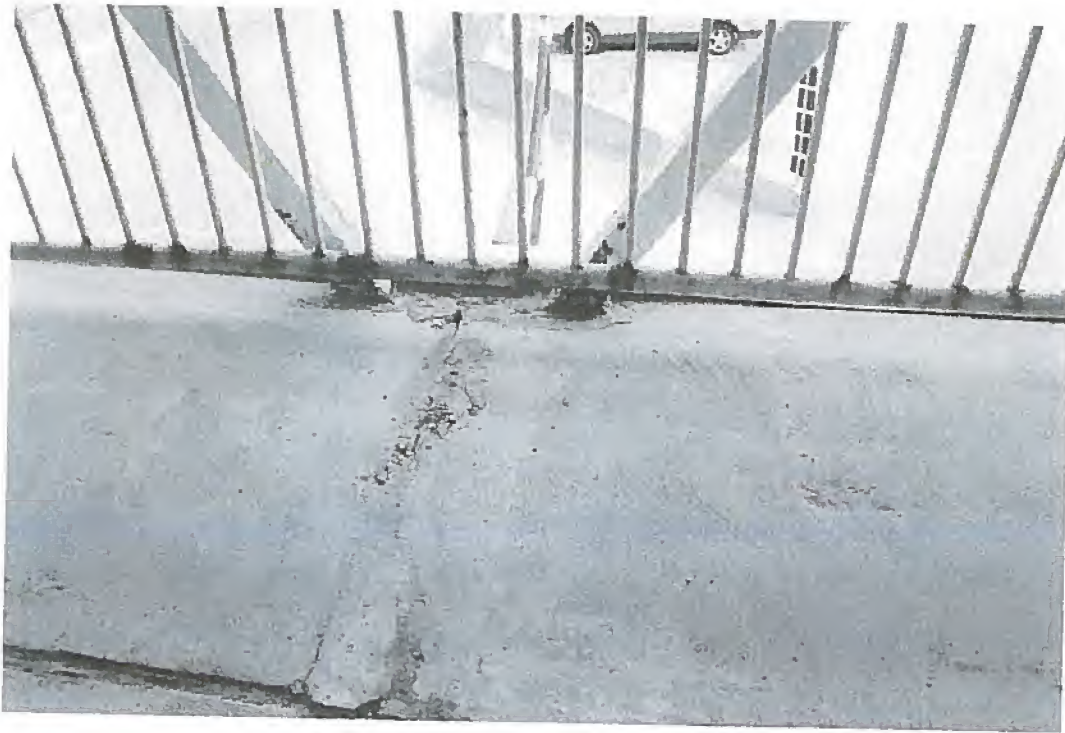
Picture 11: Rusting steel at base of diagonal HSS members of open walkway.

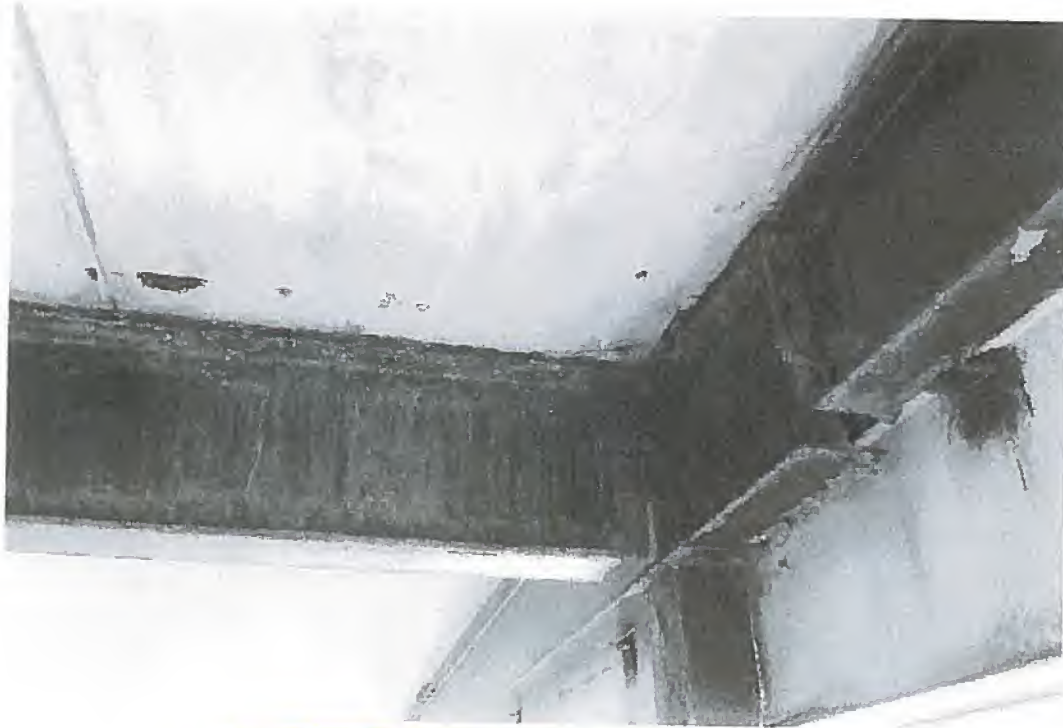
Picture 12: Rusting steel U/S of deck of open walkway.

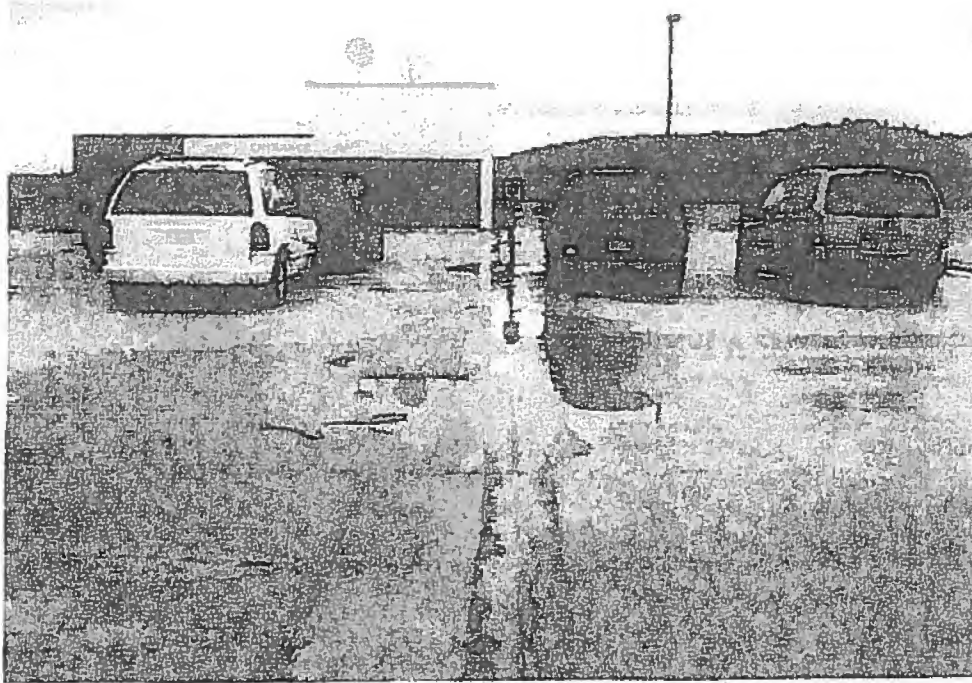
There are several leakage areas, within the Zellers Store predominately at grid lines. Our inspection revealed that grid line 5 was the most severe. At this location elaborate collection systems have been installed above the suspended ceiling to collect water infiltration through the roof structure. Picture 1 and 2 illustrate that water ponds on the parking area above this grid line beam and this appears to further aggravating the condition. It appears that the positive camber in the prestressed slabs is greater than the slope provided in structural steel frame, and thus water cannot flow to the drains on grid line 4.

Based upon the above it is our opinion that our inspection revealed no visual structural concerns both with the structural steel or prestressed slabs. The positive camber on the slabs appear to inhibit surface drainage. This indicates structurally that the slabs have significant additional load carrying capacity.

Picture 1: Grid Line 5 water ponding on parking deck despite the design in structure slope to drains on Grid Line 4 ponding appears to be due to positive camber of precast slabs.

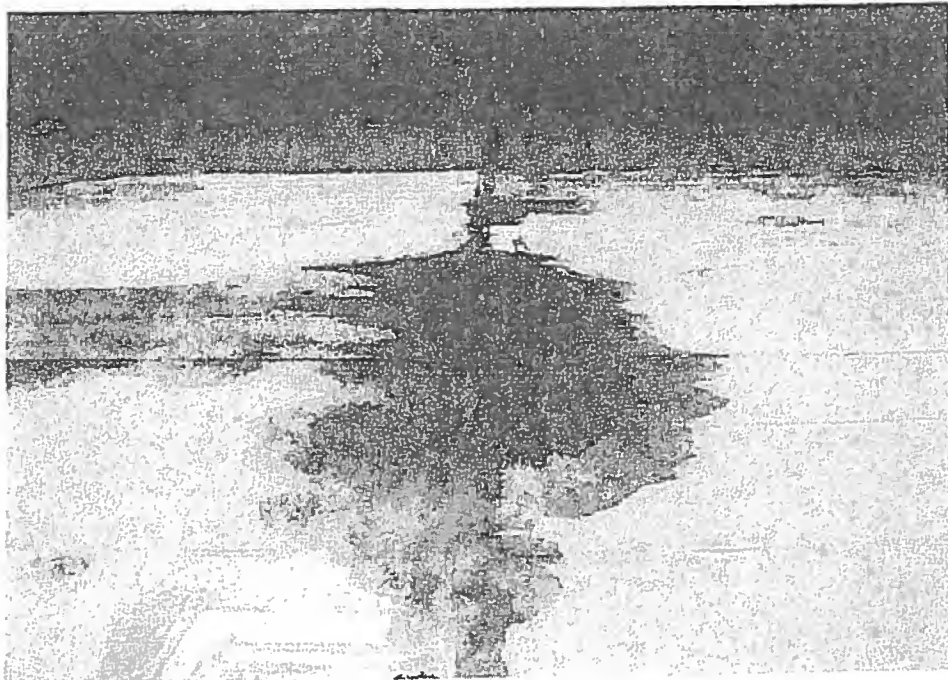
At the time of our inspection the installation of additional caulking and waterproofing repairs were still in progress on the parking deck over the Zellers Store at the south end of the Mall. Inspection revealed that the concrete topping has been saw cut and caulked at 4 foot intervals north to south and along each beam location on grid lines. Efforts over the years appear to have attempted to waterproof the mall utilizing the concrete topping and the noted caulked joints located over joints in the precast slabs with no waterproofing membrane, See Pictures 1 and 2.

Picture 2: Typical water ponding on Line 5 over steel beam support for precast slabs. Observe black tarred joints every 4 feet.

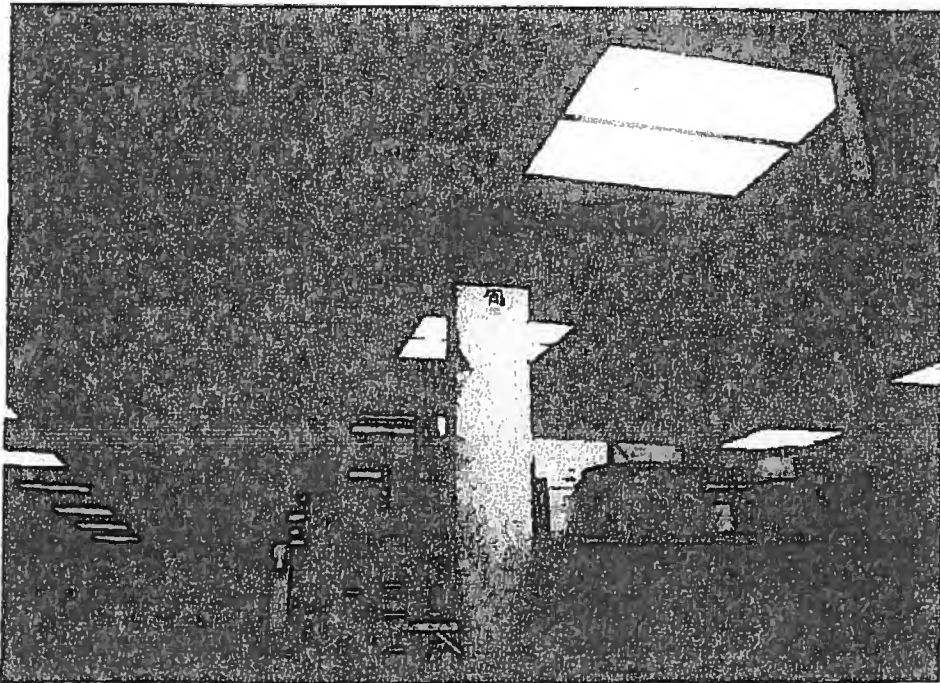
Picture 3: Line 5 in Zellers below water ponding in Picture 2. Top shelf brown storage bin right of column collects water, half full at time of inspection.

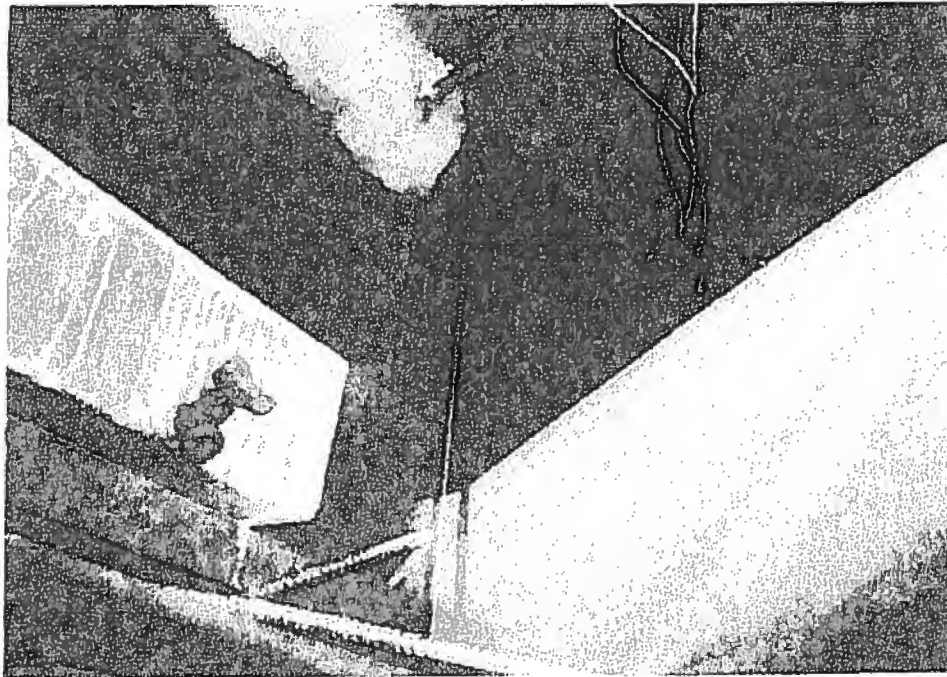
The structural steel is not fire-rated throughout Zellers. The primer painted structural steel has surface rusting, but in all areas inspected no loss of steel section was observed.

Picture 4: Yellow tarp and galvanized eavestrough with faucet to collect water penetration through slab steel not fire-rated in Zellers. Only surface rusting on beams.

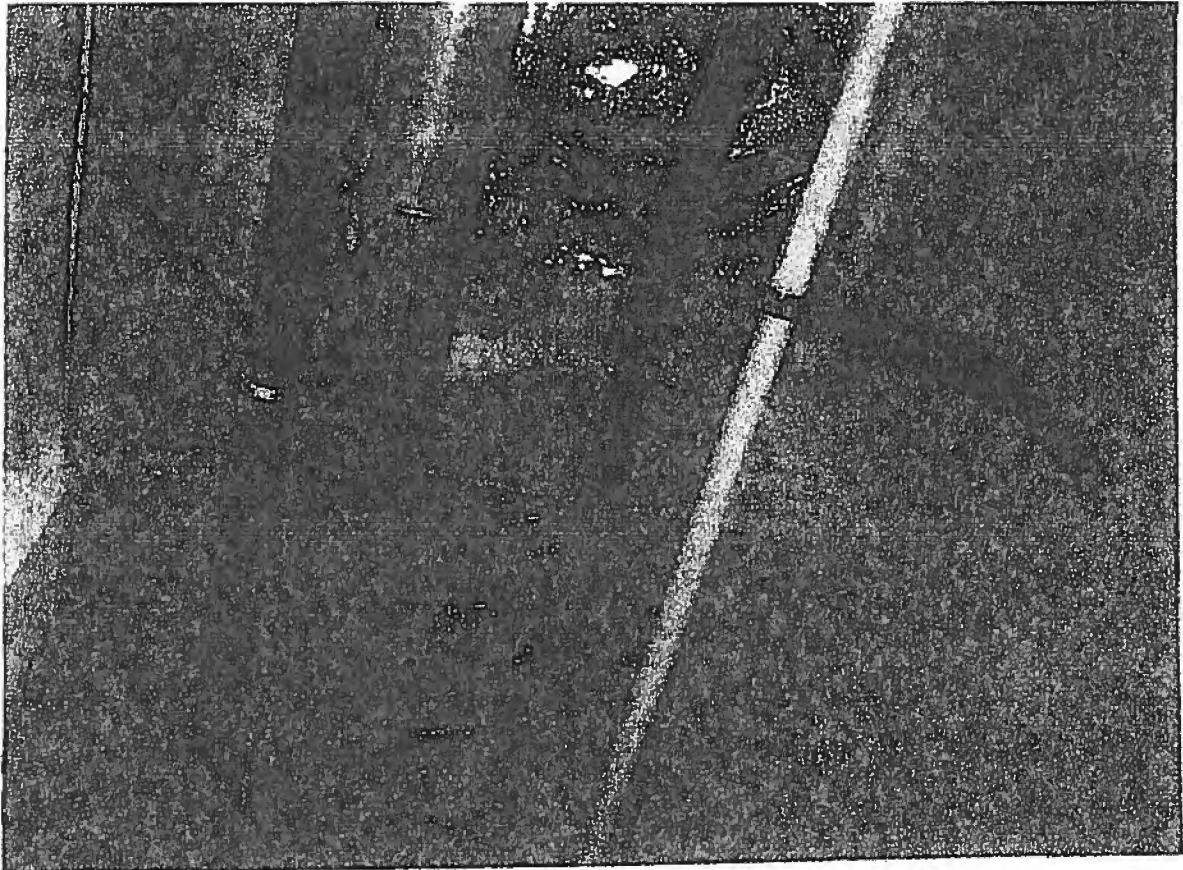
Water leakage has occurred into the perimeter corridor structure around the upper mall mostly at steel beam support locations, where there is a joint in the precast slabs. Water has soaked the sprayed-on fireproofing and the fire proofing has fallen off the bottom flange in many areas as shown in the photograph.

The steel is rusting particularly on the top of the bottom flange, however, we are of the opinion that the rusting has not created any structural loss of beam capacity. We could not inspect the underside of the precast slabs, due to the covering of foil faced fibreglas insulation.

Picture 5: Corridor west of hotel. Past leakage has resulted in removal of fire proofing. BTM flange still has primer paint. Minimal rusting on top of bottom flange.

Our major concern is the loss of fireproofing on the bottom flange of steel beams that are required to have complete fire protection. We are recommending that in areas where the original fireproofing has fallen away that the top and bottom surfaces of the bottom flange be cleaned off and suitably sprayed with a fireproofing product that is not water absorbent.

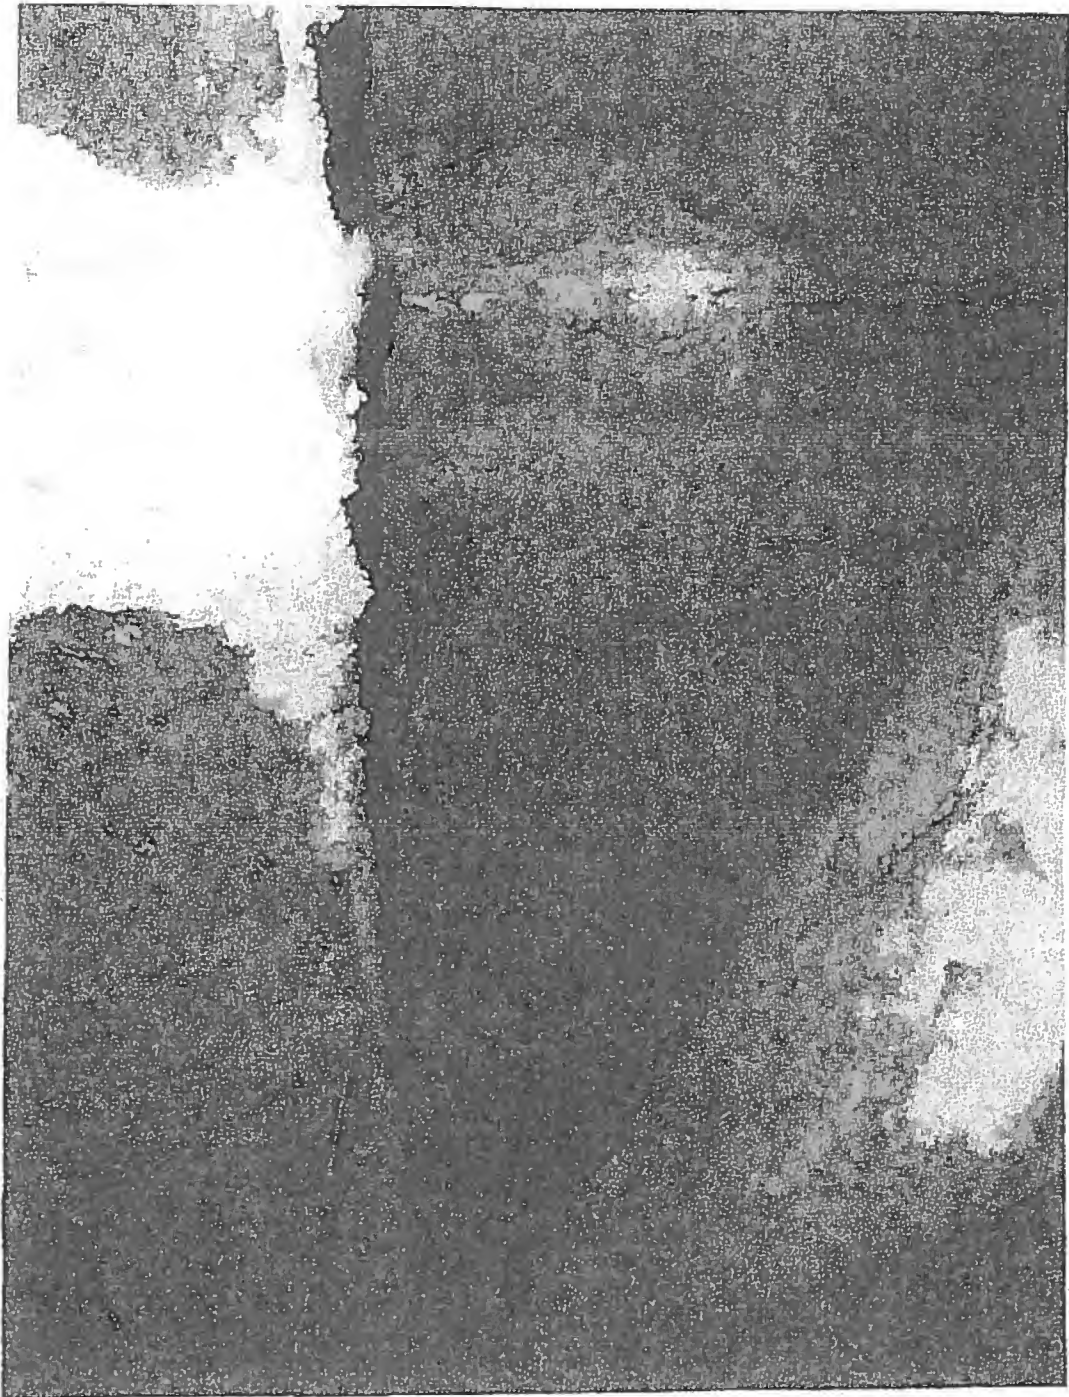
The steel beams along Line 16 are in a location of significant previous water leaks. A new roof deck drain appears to have been extended into this area to assist in the leakage control.

In this area on the north side of the beams the insulation batts have fallen away exposing the underside of the precast slabs. Signs of leakage shown in Picture 6 appear to coincide with the 4 foot spacing of the joints in the precast concrete. No deterioration of the precast slabs was observed.

Picture 6: Exposed underside of right parking area. Precast slabs right of beam leakage location at ticket kiosk in Mall, Grid Line 16 efflorescence stain at precast slab joints and fire proofing has fallen off bottom flange of steel support beam.

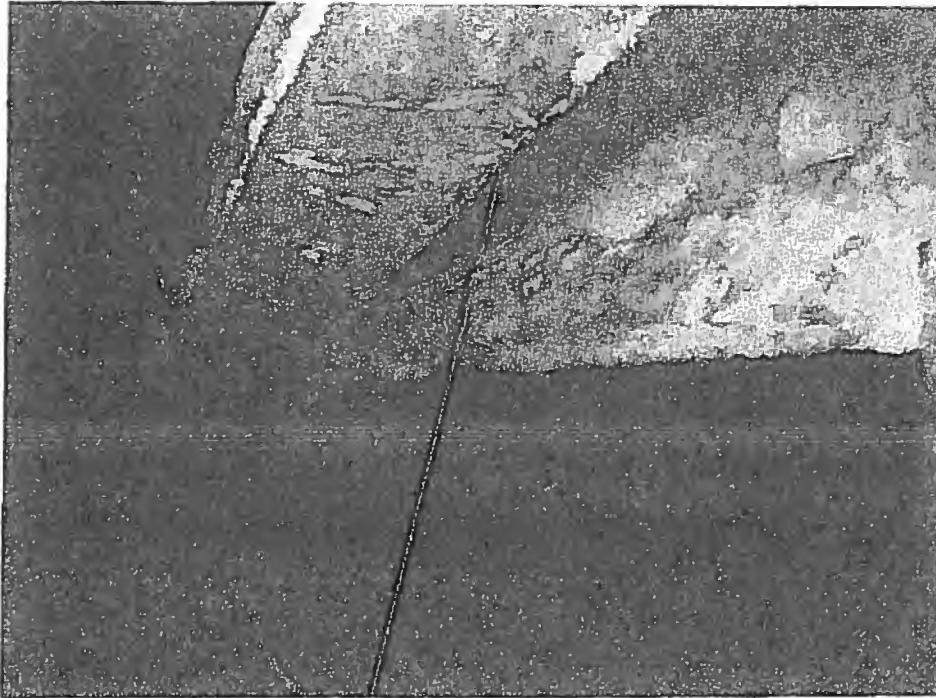
Similar to other areas inspected much of the exposed steel has only minor surface rusting with exposed original primer paint, where the fireproofing has fallen off due to water saturation.

Picture 7: Missing fireproofing bottom flange of beam at Ticket Kiosk in mall.
Insulation fallen off precast slabs.

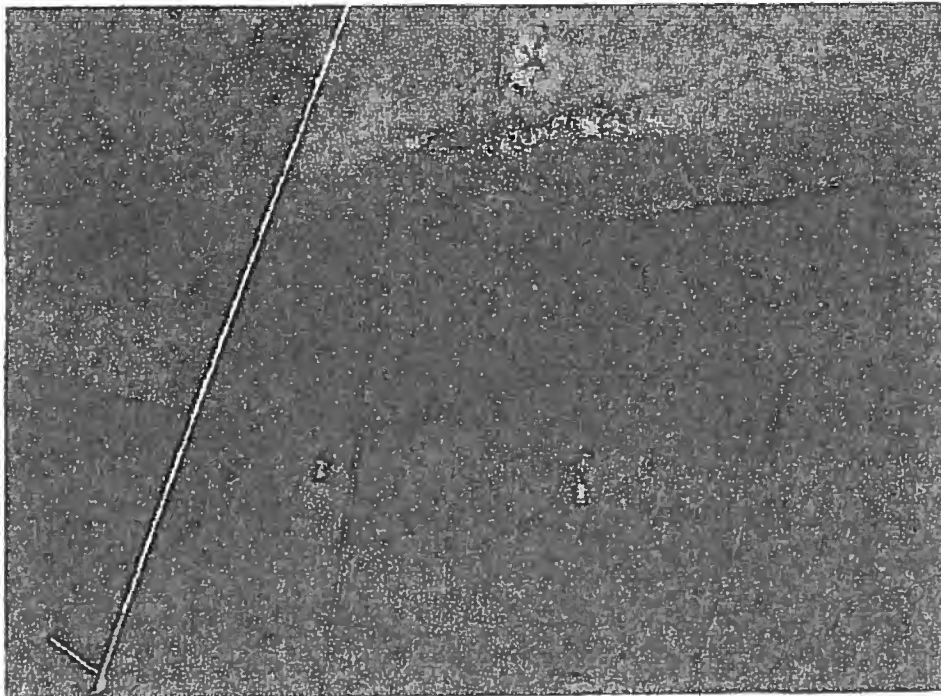
Beams in areas of leaks over the Bargain Shop have fireproofing missing on bottom flange of steel beams. No loss of section of the steel beams was observed

Picture 8: Fireproof missing bottom flange steel beams in Bargain Shop.
